**URGENT Field Safety Notice**

Zenition 10 and Zenition 30  
Arcing in X-ray tube potentially leading to temporary loss of imaging functionality

28-APR-2026

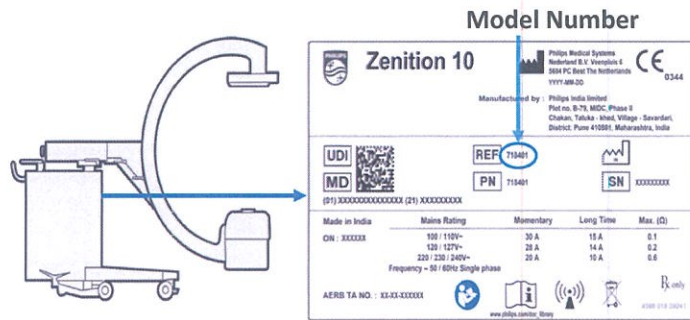
\* Fig-1 C-arm stand  
(System Identification Label location)

The Model Number and Product Name can be found on the System Identification Label (Fig-2). This label is placed on the rear side of the C-arm stand (Fig-1).
