Field Action Notice

Product: ABL800, ABL9, ABL90 and AQT90

December 12, 2025

Subject: Cybersecurity vulnerabilities

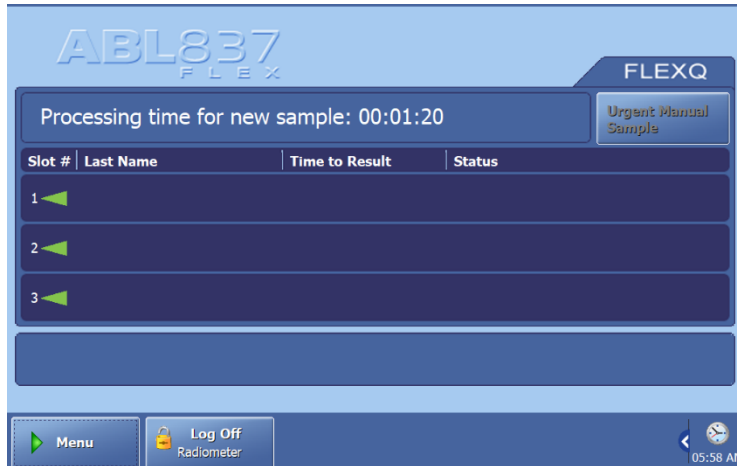
1. Connect the physical keyboard or connect the device as an external remote if available.
2. Log in as the Radiometer FSE user in case of updating directly in the device.

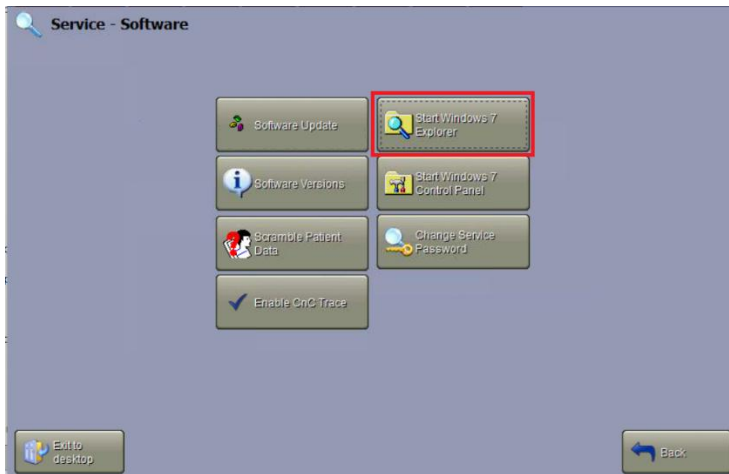
- Open the Explorer by following the path [Menu] -> [Utilities] -> [Service] -> [Software] -> [Start windows 7 Explorer]

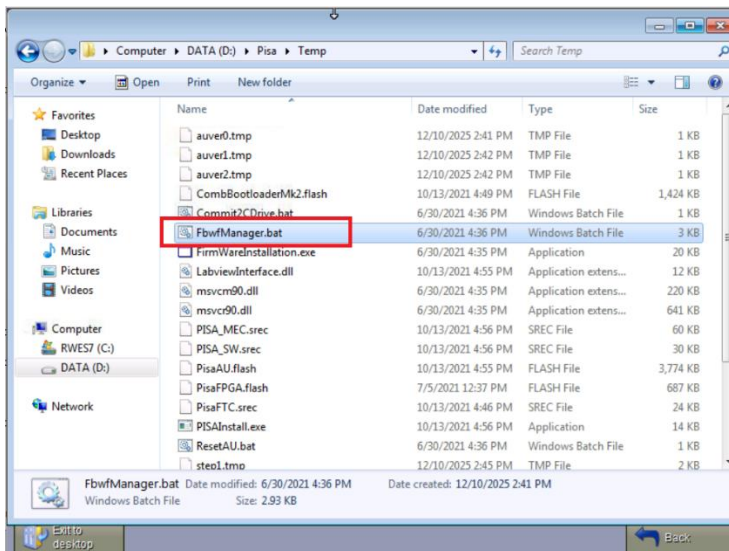
- Disable File-Based Write Filter: run **FbwfManager.bat** from the path D:\Pisa\Temp.

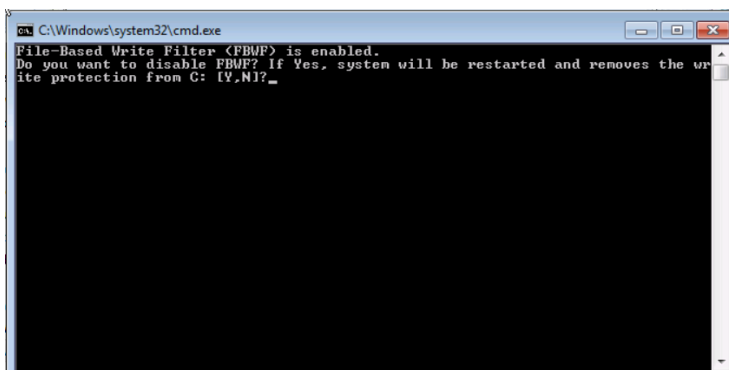
- Press Y to disable the write filter and restart the analyzer.

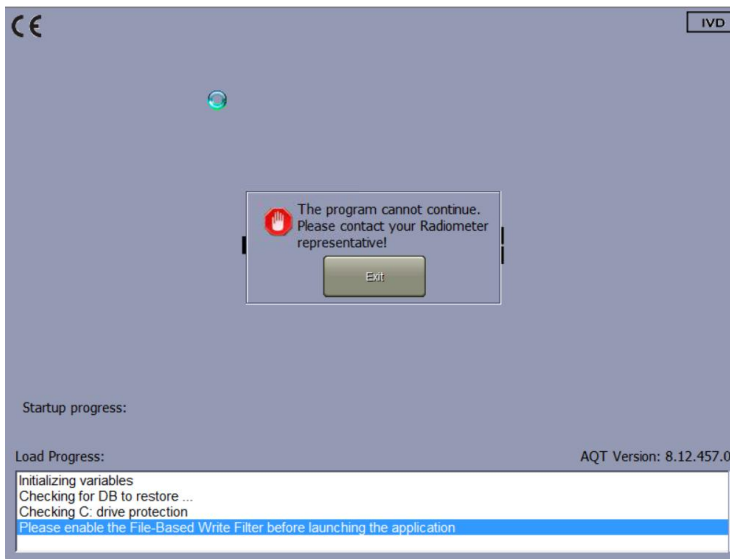
- 7. When the error below appears, to contact Radiometer representative, press *Ctrl + Alt + Delete*.

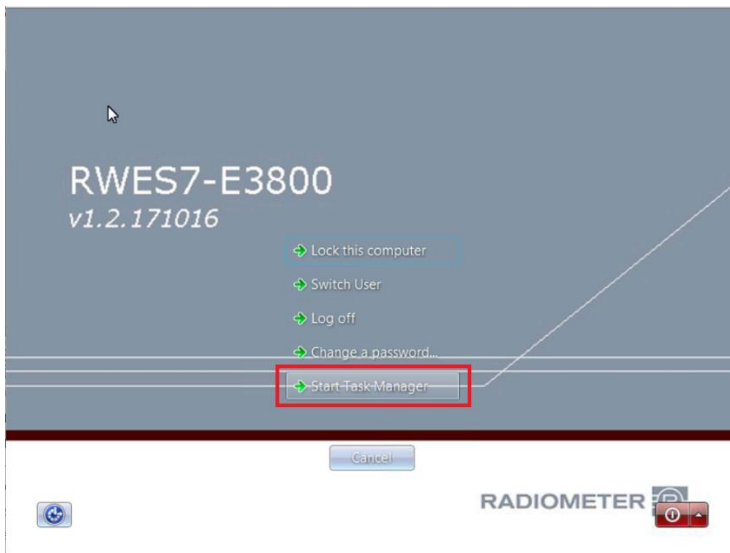
- 8. Open Task Manager.

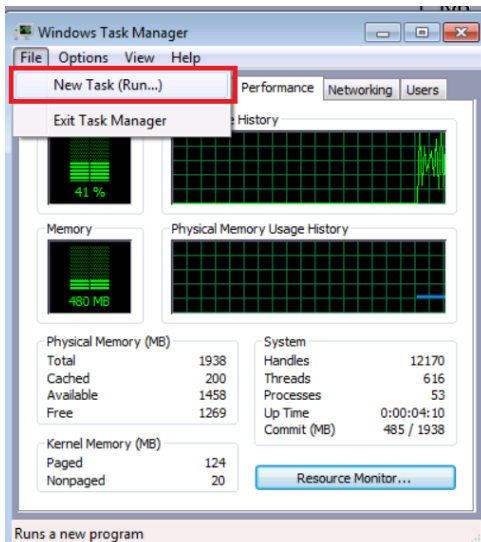
- 9. Open and run in cmd: `gpedit.msc`.
